**Flood Control Project Maintenance
Levee Inspections**
LMA District Cover Sheet
Spring 2019 Levee Inspection Results

Sacramento Maintenance Yard West Levee Yolo Bypass

Levee Inspection Report By Mile - Spring 2019

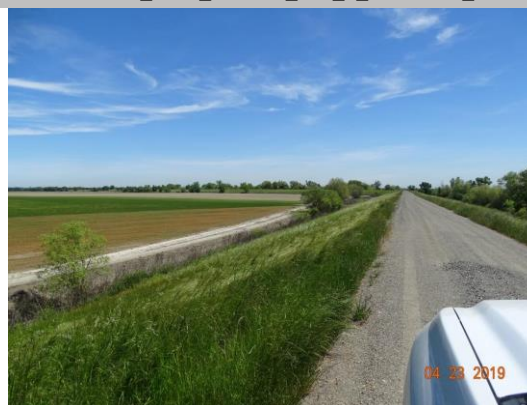
Photo 1 of 1 : SP_2019_ST0011_291_3_20190424_00016.jpg

View of vegetation on the landside slope. Spring 2019.

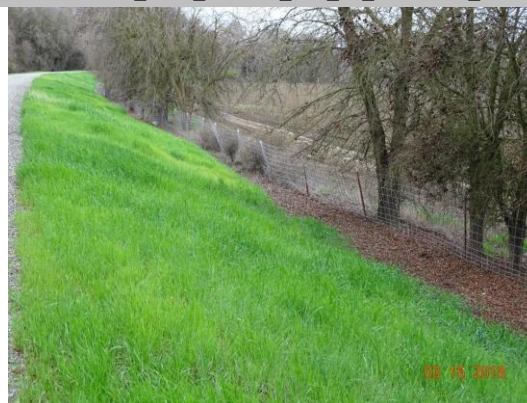
Photo 1 of 3 : SP_2019_ST0011_291_10_20190304_00005.jpg

LM Start	0.12	Rating **	M	Issue No.	10
LM End	1.55	Issue Type +	En	Location *	LS
Category	Earthen Levee			GPS Latitude/Longitude	
				Start	End
Item	Encroachments			38.758827 °	38.738955 °
				-121.665492 °	-121.660280 °
DWR ID	DWR_ST0011_01_f_2016_10				
Comment Code					
FE : Fence					
Inspector Comment

Updated view of fence at landside toe. Spring 2018.

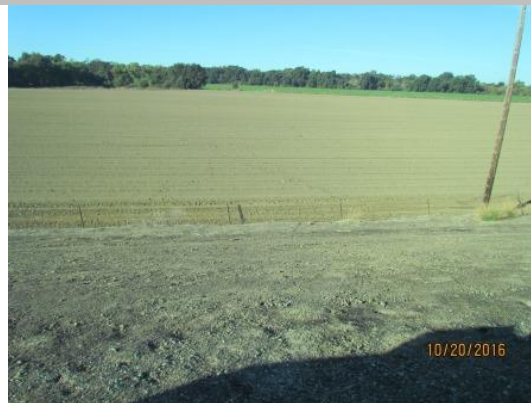
Photo 2 of 3 : SP_2019_ST0011_291_10_20190304_00006.jpg

View of fence located within 10-foot easement of landside toe. Fall 2016.

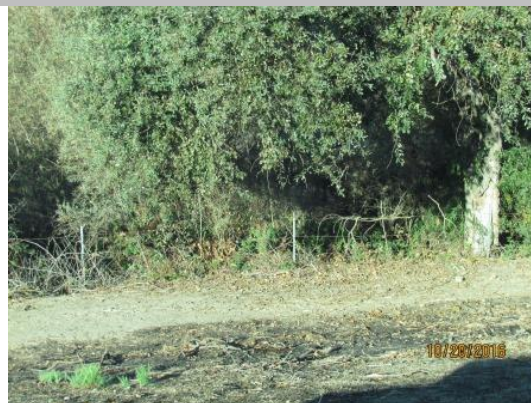
Photo 3 of 3 : SP_2019_ST0011_291_10_20190304_00007.jpg

Another view of fence located within 10-foot easement of landside toe. Fall 2016.

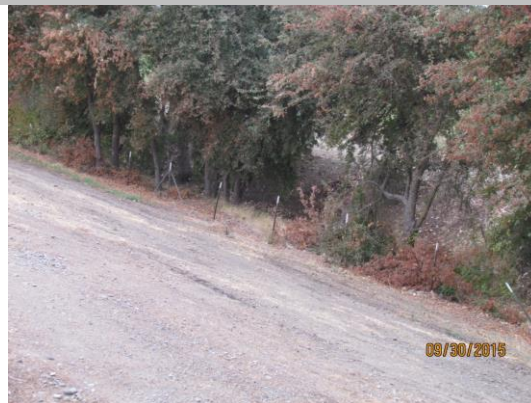
Photo 1 of 1 : SP_2019_ST0011_291_8_20190304_00002.jpg

View of the ditch on the landward side of the levee. Fall 2015.

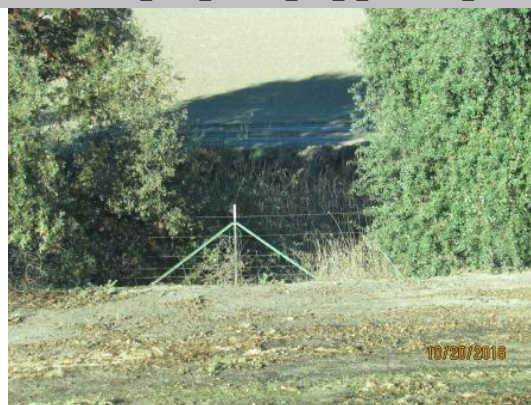
Photo 1 of 2 : SP_2019_ST0011_291_9_20190304_00003.jpg

LM Start	1.70	Rating **	M	Issue No.	9
LM End	1.79	Issue Type +	En	Location *	LS
Category	Earthen Levee			GPS Latitude/Longitude	
				Start	End
Item	Encroachments			38.736842 °	38.735498 °
				-121.660285 °	-121.660287 °
DWR ID	DWR_ST0011_01_f_2016_9				
Comment Code					
FE : Fence					
Inspector Comment

View of fence along the ditch on landside. Fall 2016.

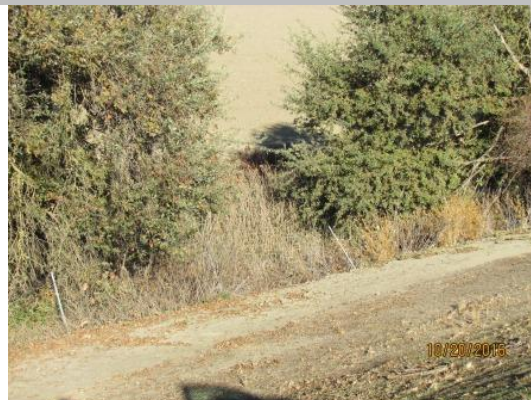
Photo 2 of 2 : SP_2019_ST0011_291_9_20190304_00004.jpg

Another view of fence along the ditch on landside. Fall 2016.

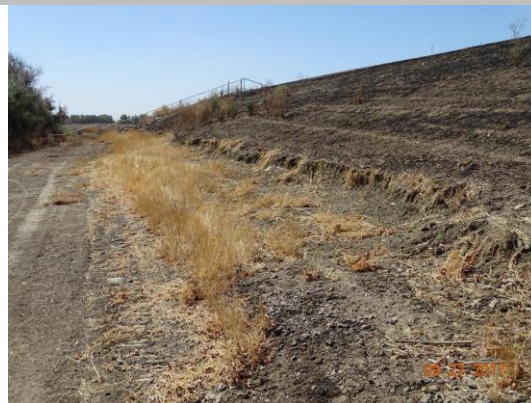
Photo 1 of 2 : SP_2019_ST0011_291_13_20190304_00008.jpg

Notes: This site had wave wash around a bend including on an access ramp. The site has been accepted for repair by USACE under PL84-99, but is a lower priority so will not be fixed before this flood season.

View of wave wash at waterside toe. Fall 2017.

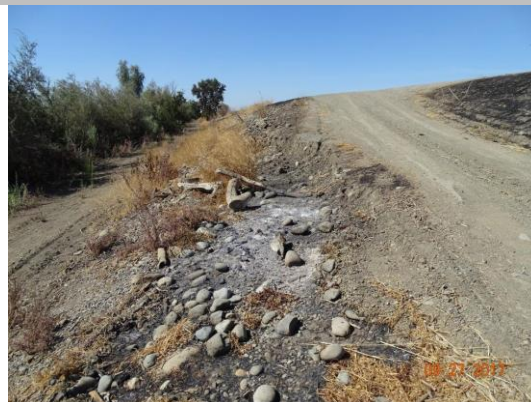
Photo 2 of 2 : SP_2019_ST0011_291_13_20190304_00009.jpg

View of wavewash on access ramp near waterside toe. Fall 2017.

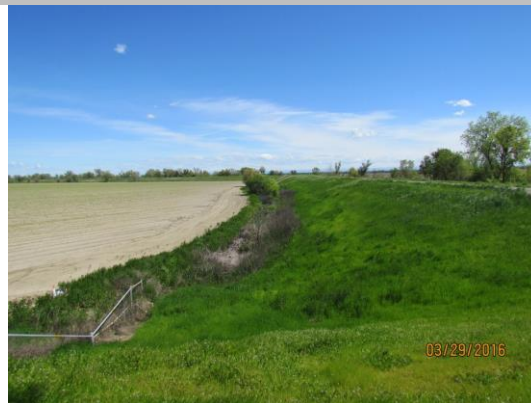
Photo 1 of 1 : SP_2019_ST0011_291_4_20190304_00001.jpg

View of the ditch at the toe of the levee on the landward side. Spring 2016.

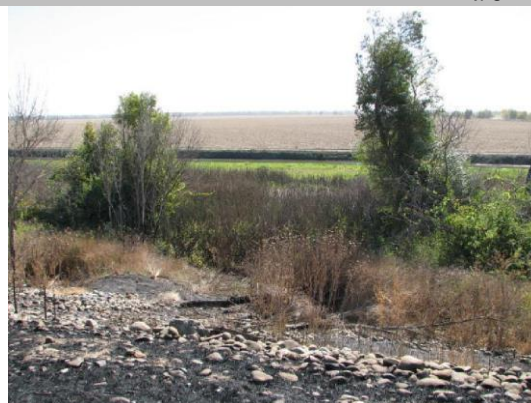
Photo 1 of 3 : UCIP_SP_2019_53232_60304.jpg

Comment Code					
Inspector Comment					
FS_ID:53232 DS_ID:17742 EP_NO: 10284 Repair Type: No Action Needed Crossing Status: Found UCIP Comments: Screw gates where removed and pipe was abanded by farmer, How pipe was abanded is unknown. Pipe is Grouted FIELD_STRUCT_DESC: 1 of 2: 42-inch corrugated metal gravity drainage pipe through the levee, 23.6 feet below the crown. Slide gate on the waterside (WS) slope. Concrete distribution box at the landside (LS) toe. (42-inch pipe [HLM 2.63] authorized under Automatic Board Order (ABO) issued as Permit No. 10284, 1974 - La Borde and Hoover). [Additional Reference(s): DWR Levee Log, 2004. USACE Sacramento O&M Manual 127, June 1953, (Station 133+82)]. FS Date: 11/16/2018 2:17:55 PM

Waterside view: overview (pipe not found)

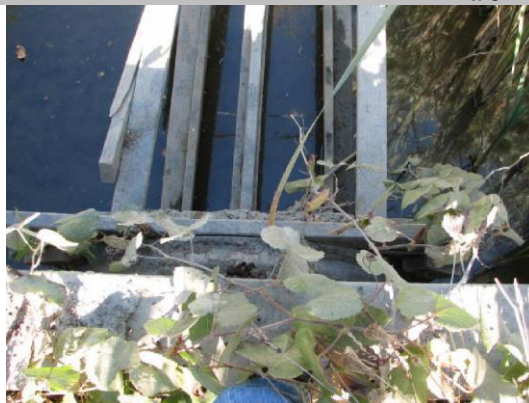
Photo 2 of 3 : UCIP_SP_2019_53232_60303.jpg

Landside view: concrete spillbox/headwall and pipe (top view)

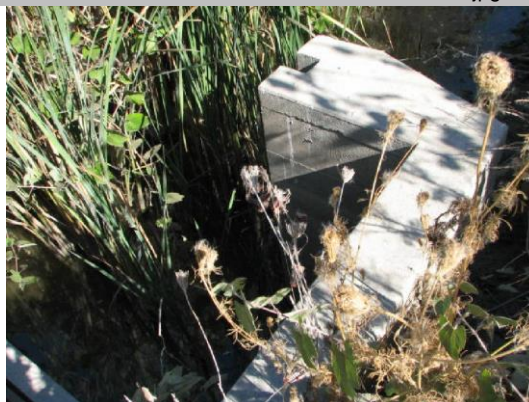
Photo 3 of 3 : UCIP_SP_2019_53232_60302.jpg

Landside view: side of concrete spillbox/headwall

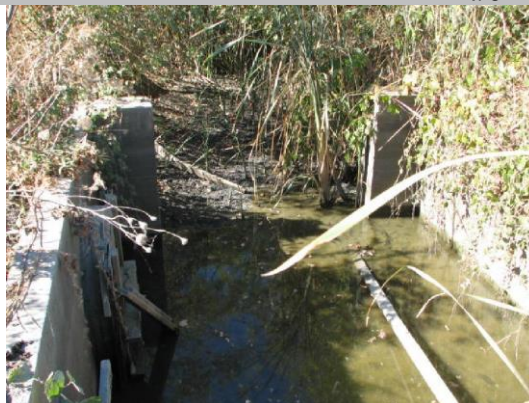
Photo 3 of 3 : UCIP_SP_2019_53233_60307.jpg

Comment Code						
Inspector Comment						
FS_ID:53233 DS_ID:17747 EP_NO: 10284 Repair Type: No Action Needed Crossing Status: Found UCIP Comments: No slide gate found. slide gates and pipes were abandon by farmer, how unknown FIELD_STRUCT_DESC: 2 of 2: 42-inch corrugated metal gravity drainage pipe through the levee, 23.6 feet below the crown. Slide gate on the waterside (WS) slope. Concrete distribution box at the landside (LS) toe. (42-inch pipe [HLM 2.63] authorized under Automatic Board Order (ABO) issued as Permit No. 10284, 1974 - La Borde and Hoover). [Additional Reference(s): DWR Levee Log, 2004. USACE Sacramento O&M Manual 127, June 1953, (Station 133+82)]. FS Date: 11/16/2018 2:19:35 PM

Landside view: CM pipe with flap gate

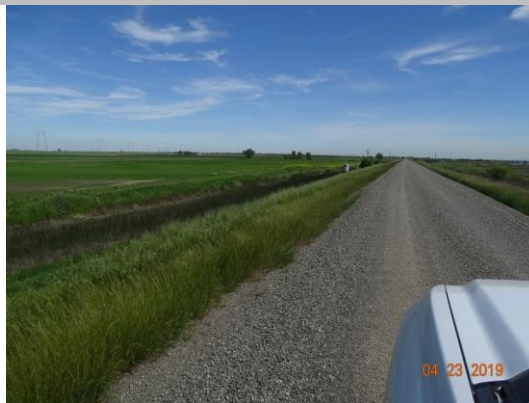
Photo 1 of 1 : SP_2019_ST0011_292_1_20190424_00006.jpg

View of vegetation on the landside slope. Spring 2019.

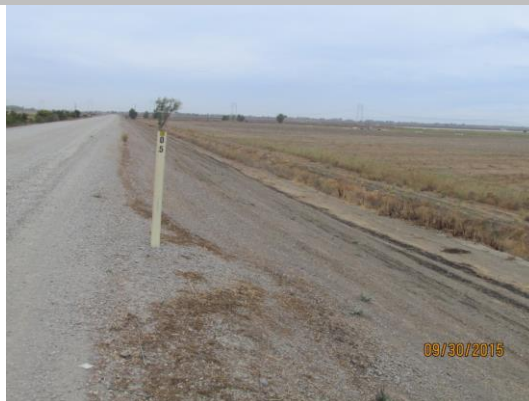
Photo 1 of 3 : SP_2019_ST0011_292_3_20190304_00001.jpg

View of the ditch at the landward side of the levee looking downstream. Fall 2015.

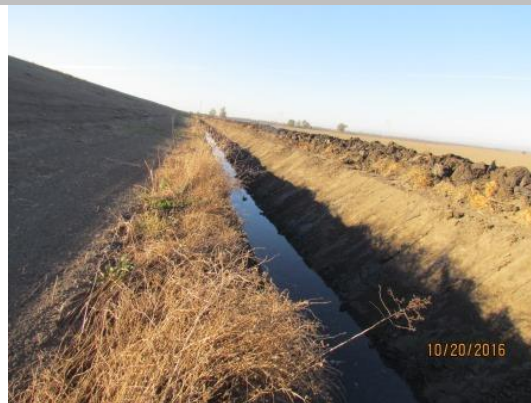
Photo 2 of 3 : SP_2019_ST0011_292_3_20190304_00002.jpg

View of the ditch on landward side. Ditch was deepened to approximately 10 ft. Fall 2016.

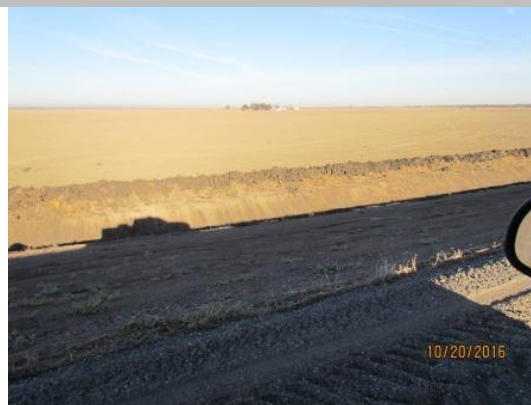
Photo 3 of 3 : SP_2019_ST0011_292_3_20190304_00003.jpg

View of the ditch on landward side. Fall 2016.

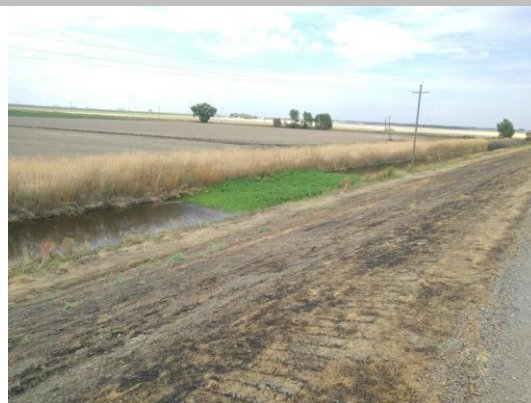
Photo 1 of 2 : SP_2019_ST0011_292_5_20190304_00004.jpg

LM Start	1.01	Rating **	M	Issue No.	5
LM End	1.44	Issue Type +	En	Location *	LS
Category	Earthen Levee			GPS Latitude/Longitude	
				Start	End
Item	Encroachments			38.705475 °	38.699637 °
				-121.671135 °	-121.674112 °
DWR ID	DWR_ST0011_02_s_2012_5				
Comment Code					
DT : Ditch					
Inspector Comment					
The ditch is at the toe of the levee.

View of ditch at landside toe, looking upstream. Fall 2017.

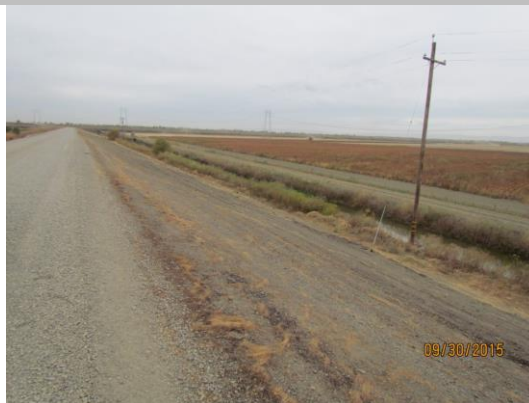
Photo 2 of 2 : SP_2019_ST0011_292_5_20190304_00005.jpg

View of the ditch on the landward side of the levee looking downstream.
Fall 2015.

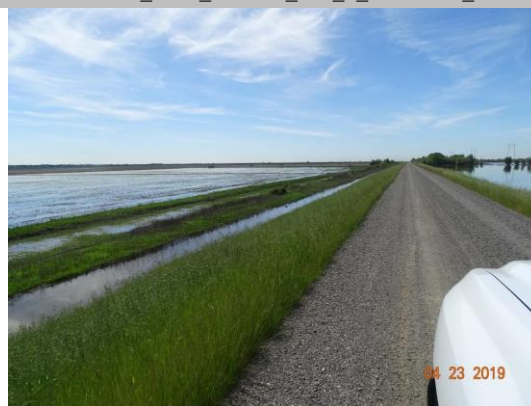
Photo 1 of 1 : SP_2019_ST0011_293_3_20190424_00004.jpg

View of vegetation on the waterside slope. Spring 2019.

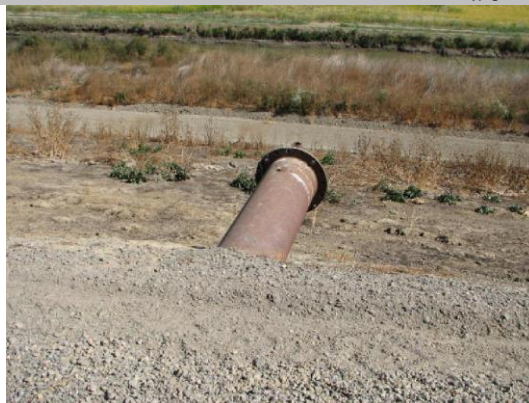
Photo 1 of 3 : UCIP_SP_2019_53252_60378.jpg

LM Start	0.03	Rating **	M	Issue No.	4	
LM End	0.03	Issue Type +	En	Location *		
Category	Supplemental			GPS Latitude/Longitude		
				Start	End	
Item	DWR UCIP Field Study			38.698204 °	38.698204 °	
				-121.674080 °	-121.674080 °	
DWR ID	17756					
Comment Code						
Inspector Comment						
FS_ID:53252 DS_ID:17756 EP_NO: N/A Repair Type: Non-Urgent Crossing Status: Found UCIP Comments: Pipe not properly abandoned. FIELD_STRUCT_DESC: *ABANDONED* 18-inch steel irrigation or drainage pipe through the levee, 3 feet below the crown. FS Date: 11/21/2018 8:24:23 AM

Waterside view: an abandoned steel pipe.

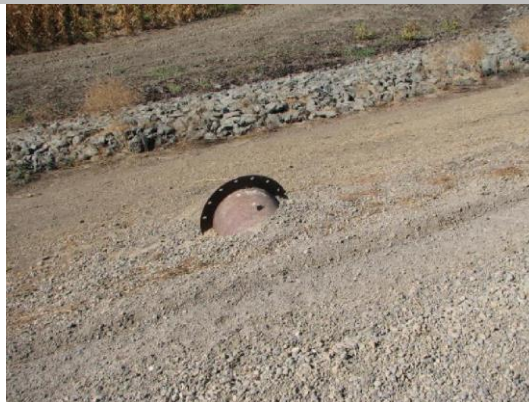
Photo 2 of 3 : UCIP_SP_2019_53252_60377.jpg

Landside view: an abandoned steel pipe.

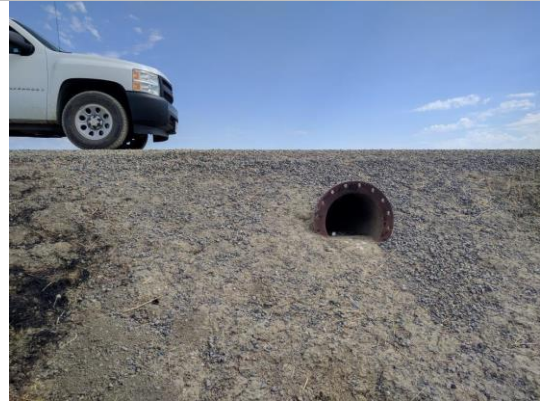
Photo 3 of 3 : UCIP_SP_2019_53252_77496.jpg

LM Start	0.03	Rating **	M	Issue No.	4 (cont)	
LM End	0.03	Issue Type +	En	Location *		
Category	Supplemental			GPS Latitude/Longitude		
				Start	End	
Item	DWR UCIP Field Study			38.698204 °	38.698204 °	
				-121.674080 °	-121.674080 °	
DWR ID	17756					
Comment Code						
Inspector Comment						
FS_ID:53252 DS_ID:17756 EP_NO: N/A Repair Type: Non-Urgent Crossing Status: Found UCIP Comments: Pipe not properly abandoned. FIELD_STRUCT_DESC: *ABANDONED* 18-inch steel irrigation or drainage pipe through the levee, 3 feet below the crown. FS Date: 11/21/2018 8:24:23 AM

LS: straight through pipe without any gates preventing water from WS to LS.

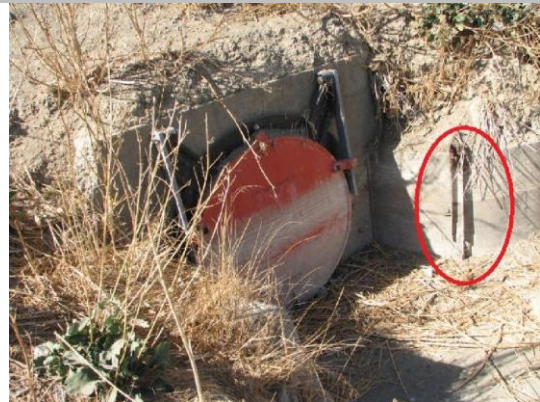
Photo 1 of 3 : UCIP_SP_2019_53860_60391.jpg

Comment Code						
Inspector Comment						
FS_ID:53860 DS_ID:17754 EP_NO: 10295 Repair Type: Urgent Crossing Status: Found UCIP Comments: 04/09/2019 Internal inspection was completed and the inspection shows separation of pipe at 22 degree turn. Sink hole visible on LS slope. Coordinating with DMP - Vince Rodriguez. Recommend repair or replace. (T. Skidgel - DWR Sacramento Yard)Found 48-inch CMP (not concrete culvert) and slide gate not found on LS end. FIELD_STRUCT_DESC: 48-inch corrugated metal pipe (CMP) sewer culvert through the levee, 18 feet below the crown. Slide gate on the landside (LS) end. (48-inch concrete culvert authorized under Automatic Board Order (ABO) issued as Permit No. 10295, 1974 - City of Woodland). [Additional Reference(s): DWR Levee Log, 2004]. FS Date: 4/9/2019 8:58:01 AM

Waterside view: flap gate and concrete headwall. Abandoned slide gate on right.

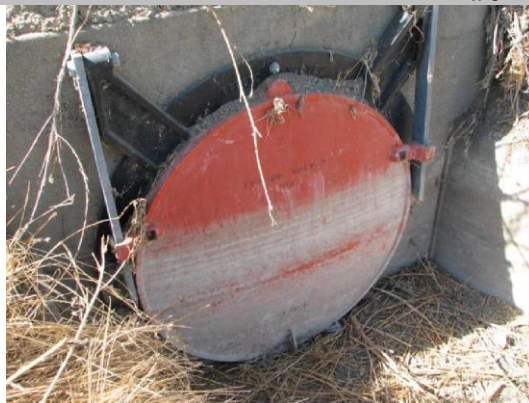
Photo 2 of 3 : UCIP_SP_2019_53860_60390.jpg

Waterside view: flap gate and concrete headwall.

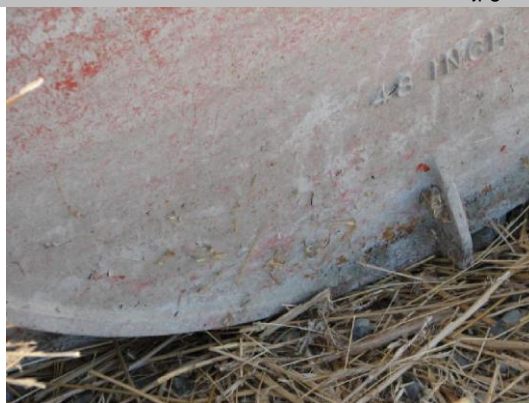
Photo 3 of 3 : UCIP_SP_2019_53860_60389.jpg

Waterside view: 48-inch flap gate.

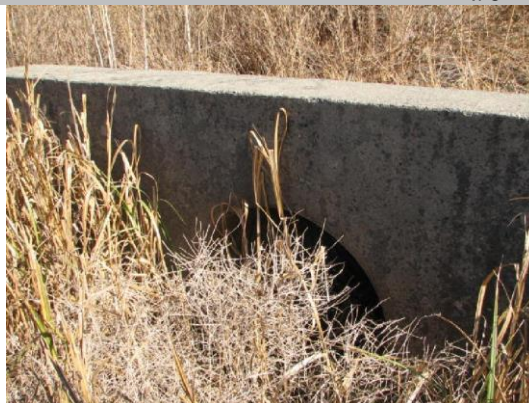
Photo 1 of 3 : UCIP_SP_2019_44826_60517.jpg

LM Start	0.60	Rating **	A/W	Issue No.	21
LM End	0.60	Issue Type +	Ma	Location *	
Category	Supplemental			GPS Latitude/Longitude	
				Start	End
Item	DWR UCIP LMA Responsibility			38.565704 °	38.565704 °
				-121.638650 °	-121.638650 °
DWR ID	528				
Comment Code					
Inspector Comment					
FS_ID:44826 DS_ID:528 EP_NO: 10304 Repair Type: No Action Needed Crossing Status: Found UCIP Comments: FIELD_STRUCT_DESC: 30-inch corrugated metal gravity drainage pipe through the levee, 22 feet below the crown. Flap gate on the waterside (WS) end. (30-inch pipe [HLM 0.59] authorized under Automatic Board Order (ABO) issued as Permit No. 10304, 1974 - Southern Pacific Transportation Company). [Additional Reference(s): DWR Levee Log, 2004. USACE Sacramento O&M Manual 120, June 1952, (Station 446+08)]. FS Date: 4/28/2015 2:58:55 PM

Landside view: concrete headwall.

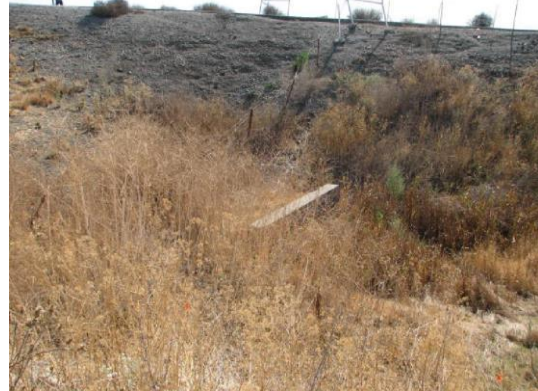
Photo 3 of 3 : UCIP_SP_2019_44826_60520.jpg

Landside view: overview

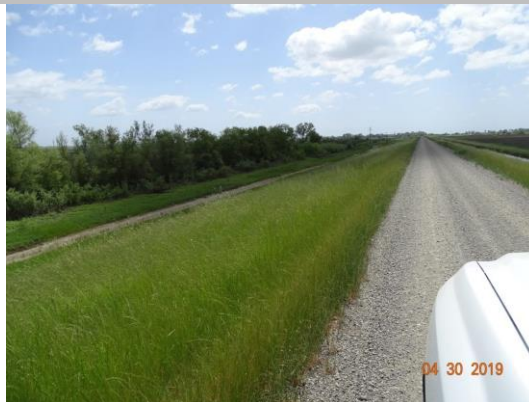
Photo 1 of 1 : SP_2019_ST0011_294_20_20190430_00016.jpg

View of vegetation on the waterside slope. Spring 2019.

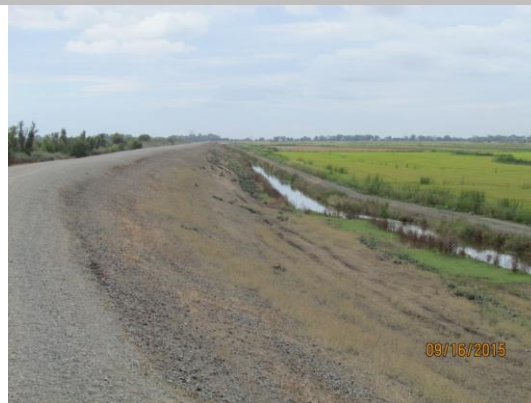
Photo 1 of 1 : SP_2019_ST0011_294_3_20190304_00001.jpg

View of the ditch along the levee toe on the landward side of the levee looking downstream. Fall 2015.

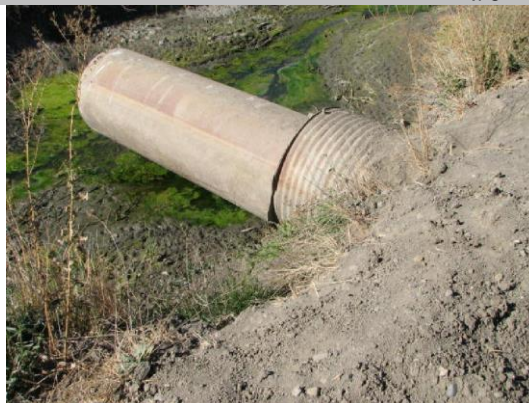
Photo 1 of 3 : UCIP_SP_2019_44822_24980.jpg

Comment Code					
Inspector Comment					
FS_ID:44822 DS_ID:17736 EP_NO: 10306 Repair Type: No Action Needed Crossing Status: Found UCIP Comments: Farmer cleans this screw gate every year FIELD_STRUCT_DESC: 48-inch corrugated metal gravity drainage pipe through the levee, 21.5 feet below the crown. 42-inch steel pipe inside the 48-inch pipe. Flap gate on the waterside (WS) with two cutoff walls, one headwall, and one saddle and apron. (48-inch pipe [HLM 2.12] authorized under Automatic Board Order (ABO) issued as Permit No. 10306, 1974 - Wells Fargo Bank, Trustees for Cowell Foundation). [Additional Reference(s): USACE Sacramento O&M Manual 119, December 1952, (Station 80+00)]. FS Date: 4/28/2015 2:57:49 PM

Landside view: 42-inch steel pipe inside a 48-inch CMP

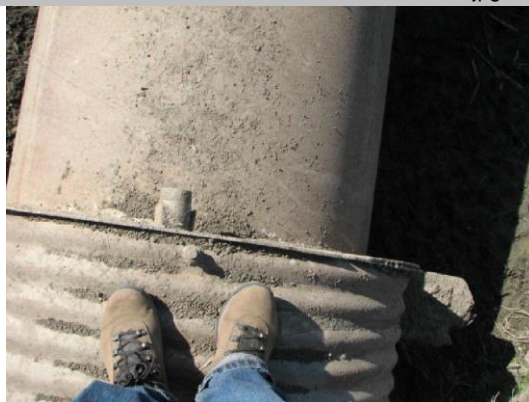
Photo 2 of 3 : UCIP_SP_2019_44822_24979.jpg

Landside view: closer look at 42-inch steel pipe and 48-inch CMP

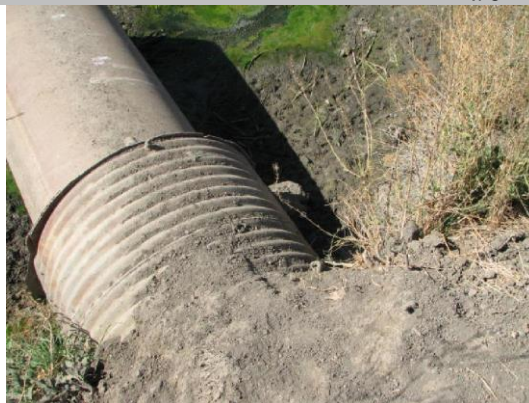
Photo 3 of 3 : UCIP_SP_2019_44822_24978.jpg

Landside view: closer look at 42-inch steel pipe and 48-inch CMP

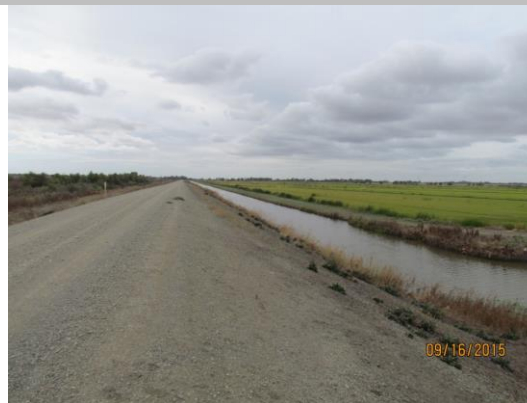
Photo 1 of 2 : SP_2019_ST0011_294_4_20190304_00002.jpg

The ditch is at the levee toe on the landward side of the levee looking downstream. Fall 2015.

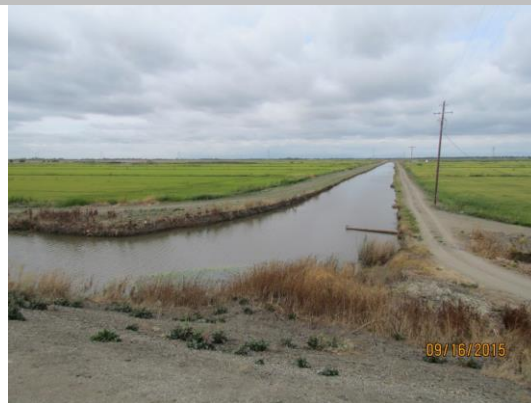
Photo 2 of 2 : SP_2019_ST0011_294_4_20190304_00003.jpg

Looking west at the agricultural ditch. Fall 2015.

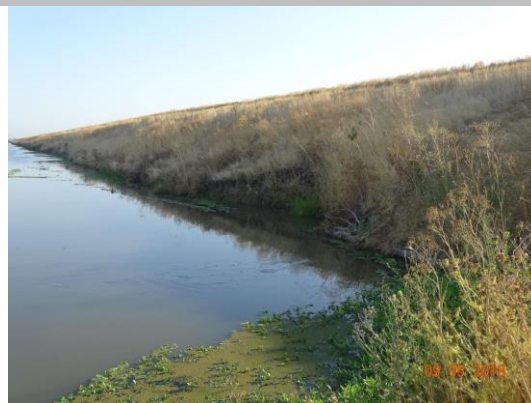
Photo 1 of 1 : SP_2019_ST0011_294_13_20190304_00005.jpg

View of erosion on the landside slope adjacent to irrigation canal. Fall 2018.
